# **Intel<sup>®</sup> Pentium<sup>®</sup> III Xeon<sup>™</sup> Processor Specification Update**

Release Date: February 2001

Order Number: 244460-025

The Pentium<sup>®</sup> III Xeon processor may contain design defects or errors known as errata that may cause the product to deviate from published specifications. Current characterized errata are documented in this Specification Update.

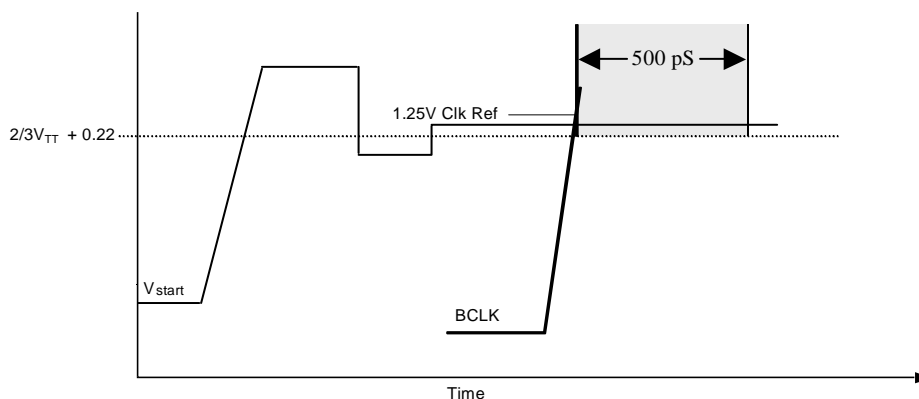
The published AGTL+ AC specification for  $V_{IH(MIN)}$  is  $(2/3 \cdot V_{TT}) + 0.1$  Volts.

Intel has characterized the new AGTL+ AC specification for  $V_{IH(MIN)}$  on the processor's RS0# signal to be:  $(2/3 \cdot V_{TT}) + 0.22$  Volts within 500 picoseconds following the rising edge of BCLK crossing the 1.25-Volt threshold. See below.

**Implication:** The deviation from the published specification results in decreased noise margin on the RS0# processor input. This decreased noise margin has been observed to be particularly detrimental in system environments where the RS0# processor input is being driven by an I/O buffer with a pull-up device (such as a p-channel transistor) that is switched off mid-cycle. Systems that employ I/O buffers that keep the pull-up device on for the entire cycle are significantly less affected by this erratum. The reduction in noise margin may lead to the generation of BINIT# (when enabled) resulting in a system reset, otherwise this condition may lead to a system "hang" condition.

**Workaround:** If a system design cannot meet the specification deviation, the following areas should be carefully examined to assure that additional margin exists in order to compensate for any deficit observed with respect to the newly characterized  $V_{IH(MIN)}$  specification:

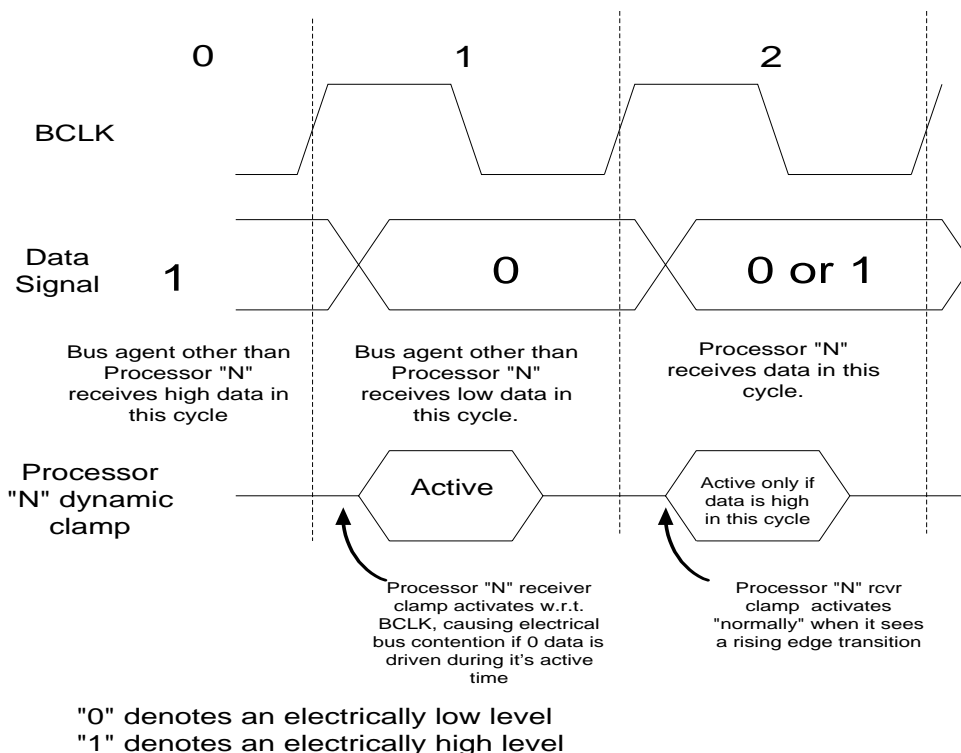
**Problem:** Falling edge ledge push-out and undershoot may be seen on AGTL+ data and data bus ECC signals. The AGTL+ receiver's dynamic clamp circuit activates (i.e. clamps the signal to an electrically high level) in certain cycles when data is driven to an electrically low level by another agent.

**Implication:** This erratum only occurs on a processor that does not receive data in that particular cycle. More specifically, this erratum only occurs when a specific processor does not receive data in the current BCLK period, but receives data in the very next period. Therefore, the processor inducing this falling edge noise (on data and data bus ECC signals) will not actually read the data in that cycle. See below for an illustration of this erratum affecting a processor denoted Processor "N". The falling edge ledges and undershoots may affect the signal quality and/or timing at agents that receive data in that cycle. Therefore, the impact of this erratum is highly dependent on system bus design.

**Workaround:** Evaluate system bus signal quality and timing margin at the valid receiving agent as a result of this falling edge noise. Due to dependence upon system bus design, bus layout may be evaluated to determine the need for improvements in signal quality and timing margin at the valid receiving agent as a result of this receiver-induced falling edge noise.
